Prepared By Gina Hoar, R.P.Bio.,
Aquatic Stewardship Specialist

MUNICIPALITY OF NORTH COWICHAN SERVICE
AGREEMENT WITH THE SOMENOS MARSH
WILDLIFE SOCIETY
ANNUAL REPORT 2022

Prepared for: Municipality of North Cowichan

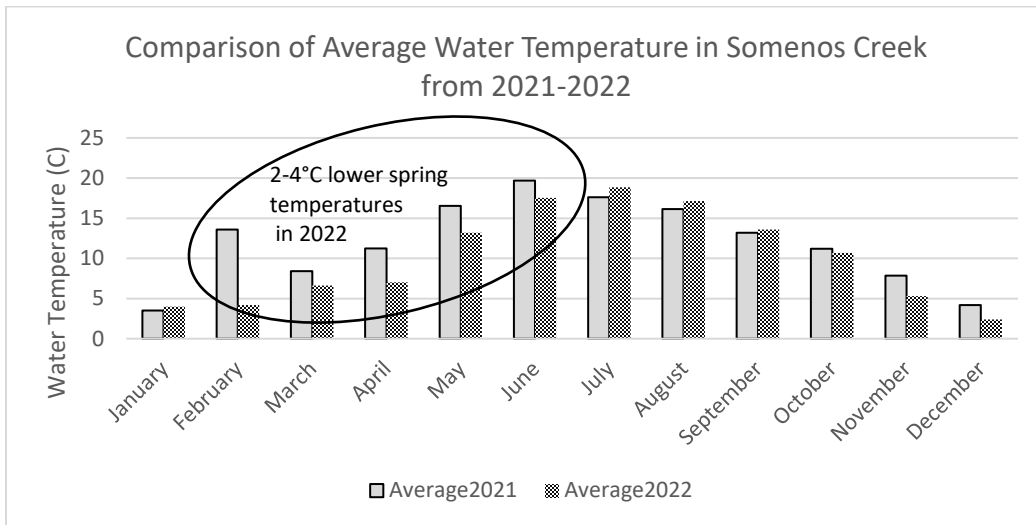
FIGURE 4: WATER TEMPERATURE COMPARISON BETWEEN 2021-2022

Parrot's Feather has grown at a slower rate compared to last year. The total amount of Parrot's Feather and peak growth in 2021 vs 2022 in all the reaches are shown below in Table 2. The results of peak growth this year are significantly lower than last year reaching only 53% coverage of Parrot's Feather overall in 2022 vs 73% at the same time last year. It is possible the cold temperatures and heavy rain in the spring of 2022 during the La Nina weather pattern may have delayed the start of Parrot's Feather regrowth, and cold temperatures in spring kept it from growing as much as it would in a normal year. Figure 4 shows the temperature on Somenos Creek from 2021 to 2022.

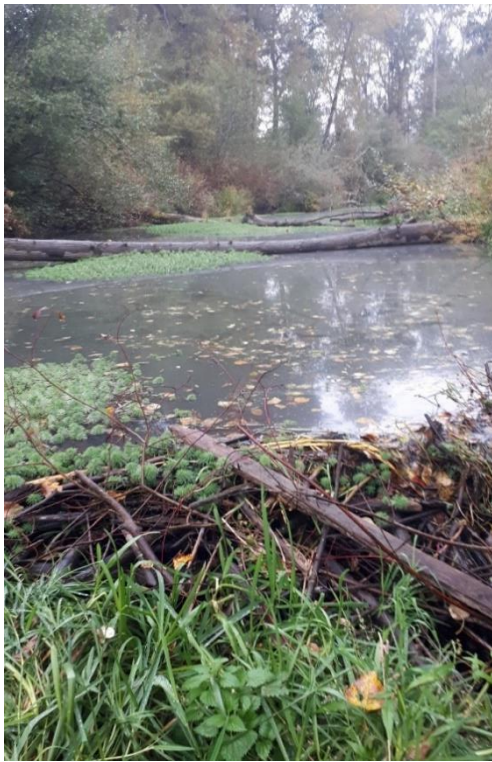
Photo 11: Upstream view of new 1.2 m high beaver dam (BD#2) barrier at the end of Reach 3. 2022

- A cold spring and high spring precipitation may have delayed initial Parrot's Feather growth
- In Reach 3 another beaver dam was built since the last survey and was blocking the Chum salmon run up into Fish Gut Alley by the October site visit (Oct. 21, 2022). By the time of the site visit on November 7th SMWS observed visible salmon waiting below the dam which was now passable for fish.

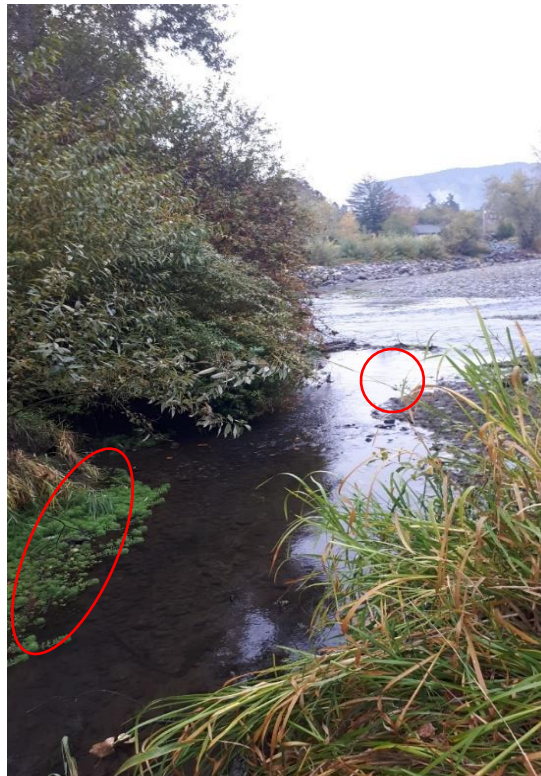
Photo 12: Downstream view from BD#2 to the Cowichan River confluence. Note: new areas of Parrot's Feather growth on Somenos Creek are reaching the Cowichan River. 2022

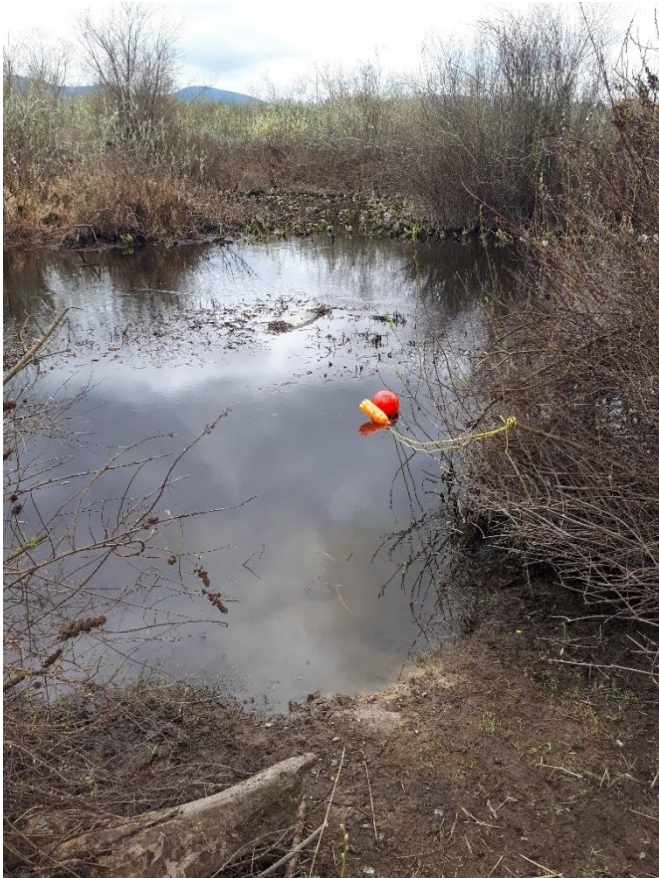
Photo 13: Pond liner inspection on April 1, 2022. Buoy is a temperature data logger at Station 3.

- Pond liner was inspected on April 1, 2022. High flows covered the pond liner and dead mats of Parrot's Feather were observed on the surface of the creek (Photo 13).
- On August 12th the first section of the pond liner was removed by SMWS staff (Photo 14-16)
- On August 30th, the last section of the pond liner was removed by SMWS staff with MNC Operations crew.
- The pond liner was removed from site and not redeployed, August 30, 2022.

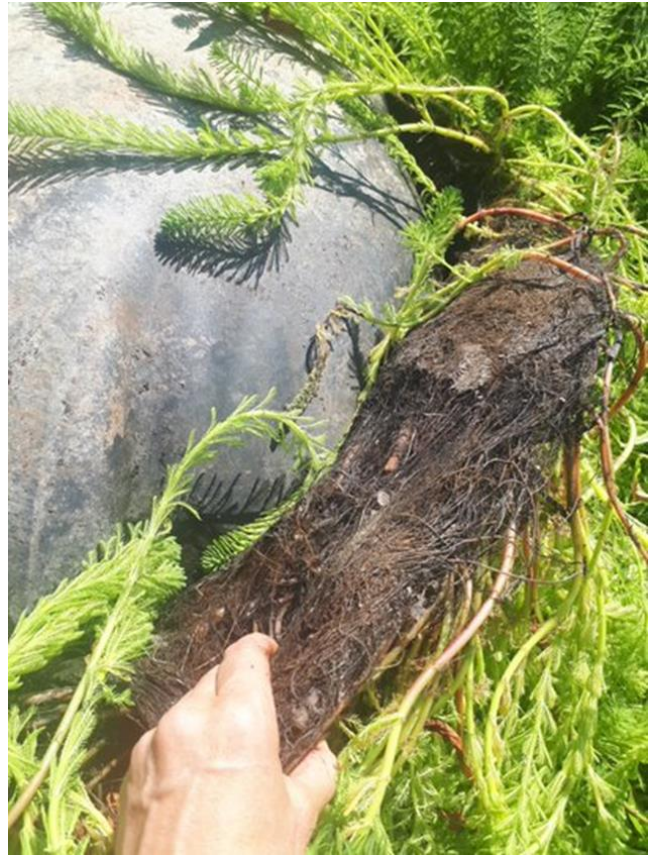
Photo 14: Parrot's Feather growing on top of the pond liner

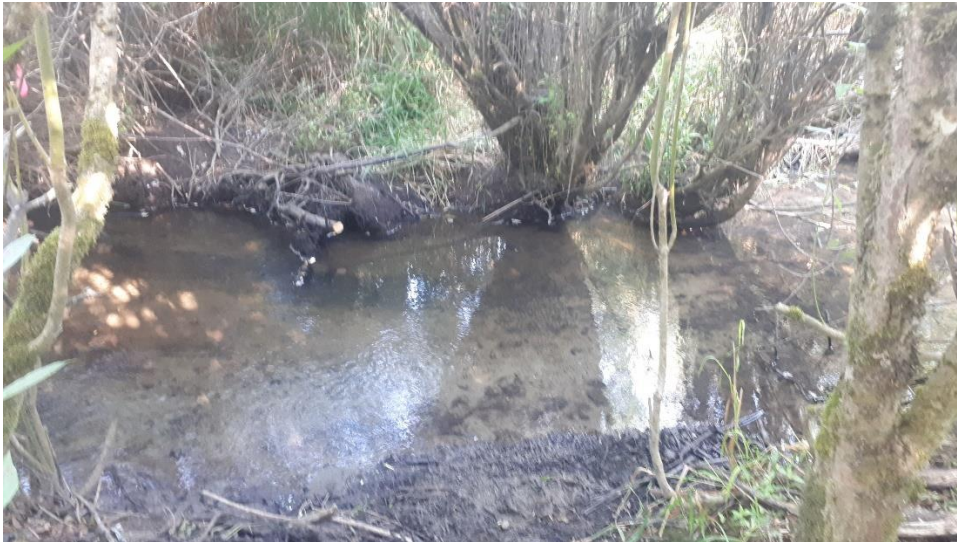
Photo 3: View looking at left downstream bank before restoration at Site 4. Habitat mainly was silt, sand, and organics.

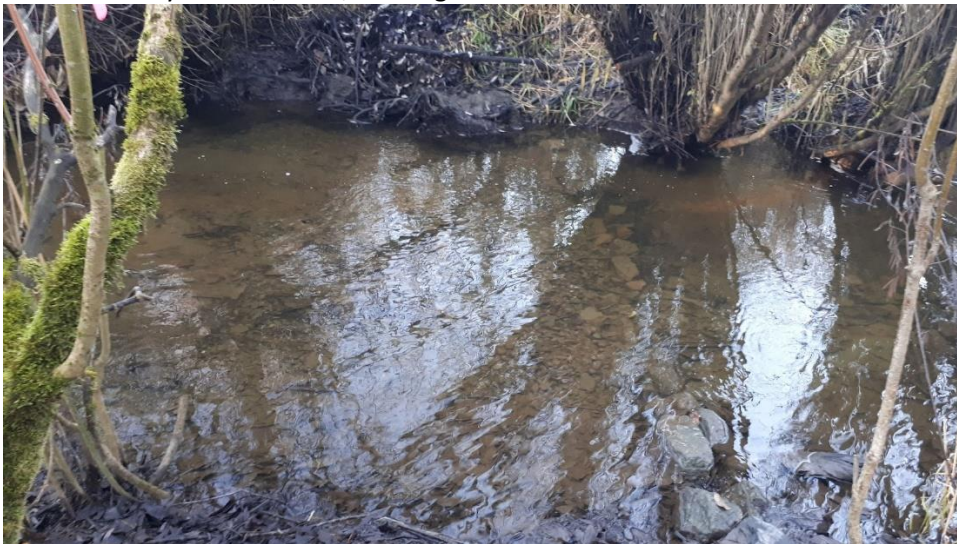
Photo 4: View looking at left downstream bank after restoration at Site 4. 1.5 tons of gravel and half ton of anchor rock were added to create spawning beds.

To begin, loose woody debris, detritus and organics was raked out of the stream and mounded on the shoreline for later use after which a half ton of anchor rock was placed across the channel in 2-3 rows to create a weir structure to hold the gravel in place. The weir was filled with salvaged muck and clay that formed a seal on the upstream side of the anchor rock. Then gravel was placed in the channel by volunteers above the weir over a 3m x 3m area using 20-liter pails during the fish work window. The gravel was emptied into the creek about 4-6 inches thick. Improvements to each site included the addition of 1.5 tons of gravel and cobble mix which will support a variety of salmon species known to spawn in the watershed.
