Prepared By Gina Hoar, R.P.Bio.,
and Phaedra Douglass, BA.

MUNICIPALITY OF NORTH COWICHAN SERVICE
AGREEMENT WITH THE SOMENOS MARSH
WILDLIFE SOCIETY
ANNUAL REPORT 2023

Prepared for: Municipality of North Cowichan

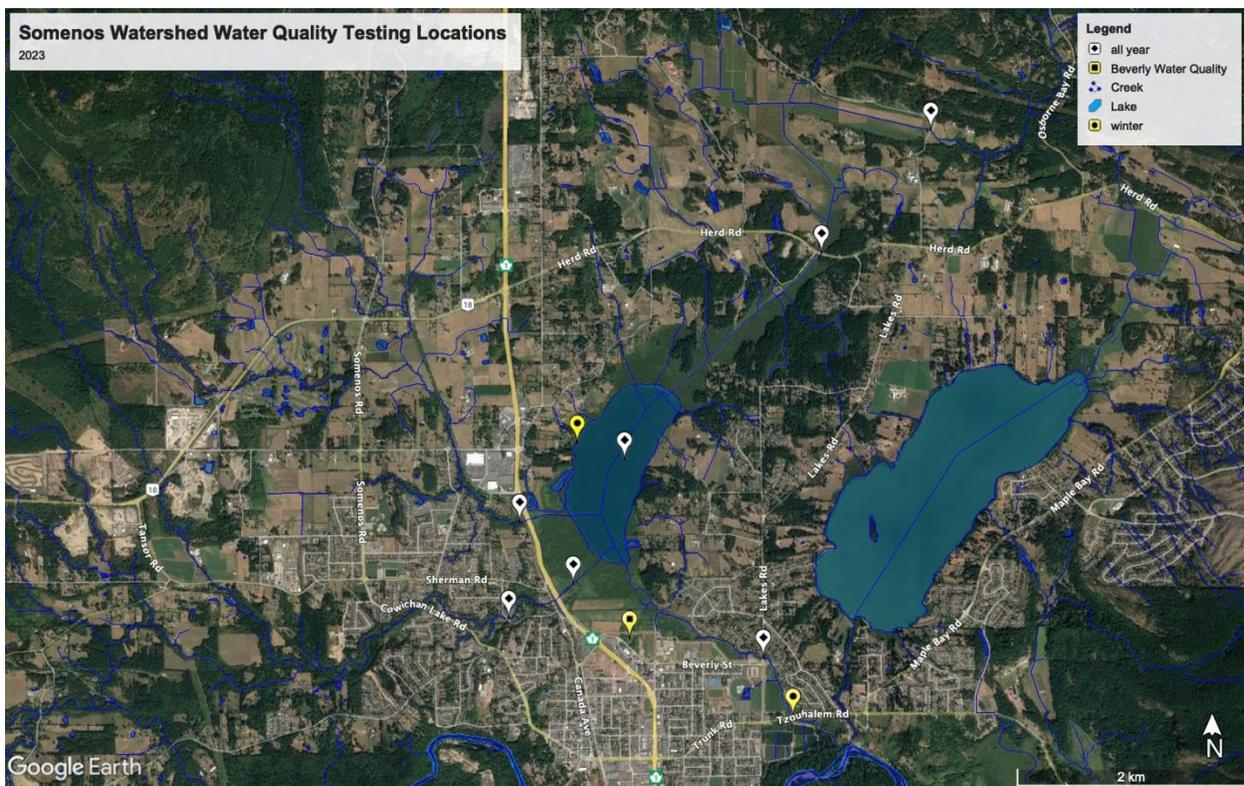
FIGURE 1: SOMENOS WATERSHED REGULAR WATER QUALITY 2023 YSI TESTING LOCATIONS

The S'amunu | Somenos Watershed (the Watershed) covers 71 km² within unceded Cowichan Tribes Territory and is mostly located within the Municipality of North Cowichan (MNC). Portions of the Watershed encompass Cowichan Tribes land, land within the City of Duncan, and the Cowichan Valley Regional District (CVRD). The watershed includes tributaries that flow from Mt. Prevost and Mt. Richards at Crofton Lake. The major tributaries are Richards, Averill, and Bings Creeks which flow into Somenos Lake, and exit into Somenos Creek. The end of the watershed study area is where Somenos Creek meets the Cowichan River. The Society has conducted water quality monitoring in Somenos Lake for the MNC since 2014 and, beginning in 2020, added monitoring of the four major tributaries: Richards, Averill, Bings, and Somenos Creeks (Figure 1).

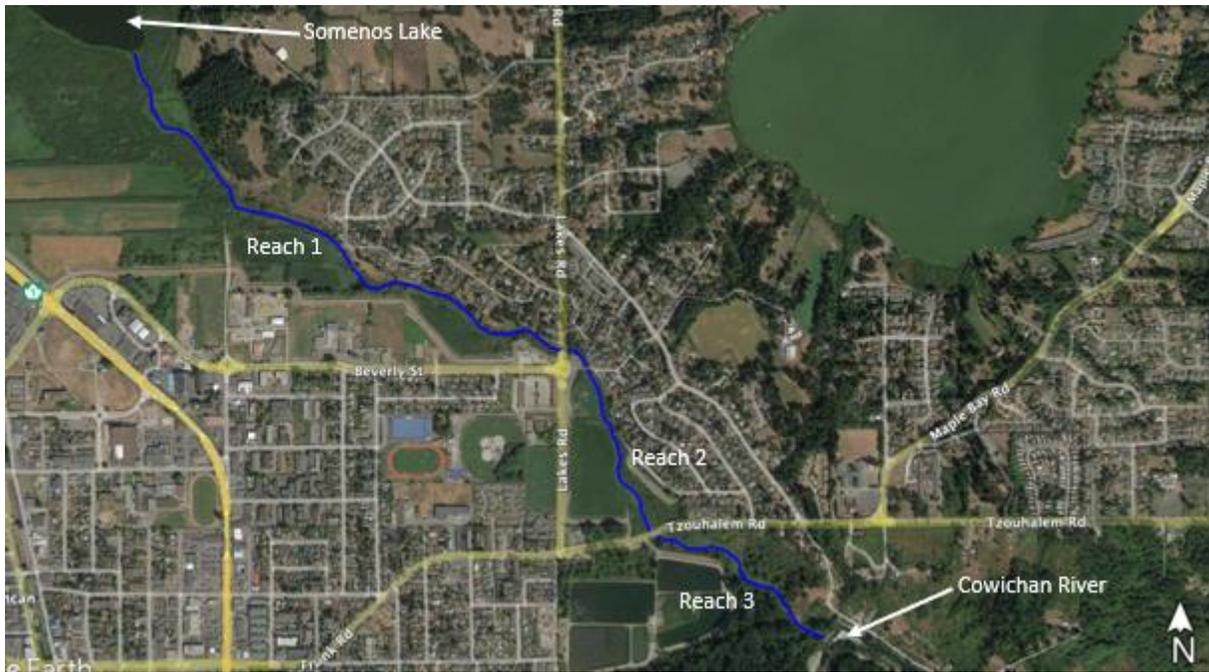
FIGURE 2: SOMENOS CREEK SURVEY REACHES 1-3

- Reach 1: Somenos Lake to Lakes Road Footbridge (Municipality of North Cowichan)
- Reach 2: Lakes Road Footbridge to Tzouhalem Road (Municipality of North Cowichan)
- Reach 3: Tzouhalem Road to Cowichan River (Cowichan Tribes)

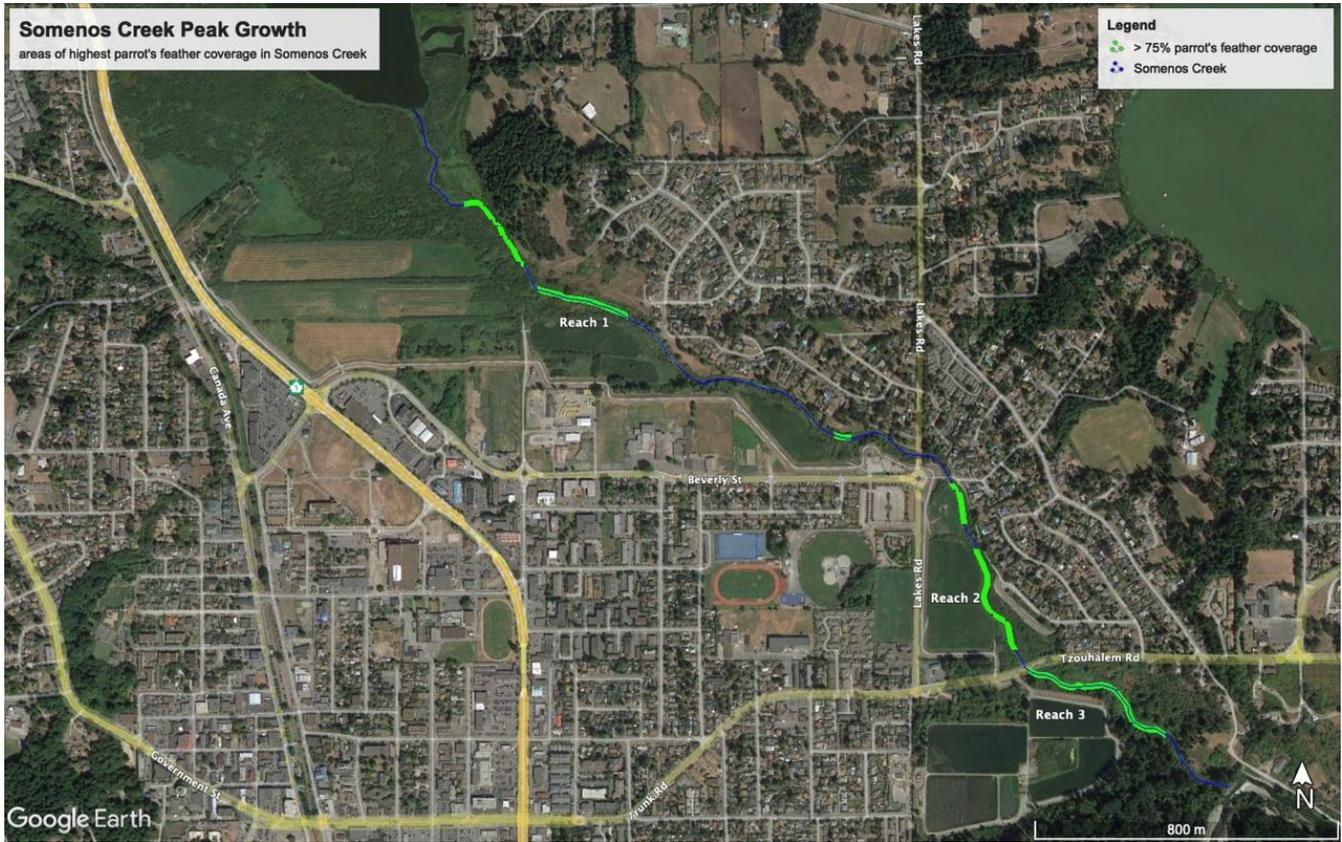
FIGURE 3: SOMENOS CREEK PEAK GROWTH 2023

- Reach 2 is adjacent to active farmland on the western shoreline and exposed to full sun, which creates perfect conditions for growth. SMWS’s long term plan is to add a treed riparian zone on the west side, to shade parrot’s feather and reduce its growth, planting begun in this area this year.

- Reach 3 heavy buildup of parrot’s feather is likely to be caused by a slow section downstream of the pipeline crossing. At the end of the green highlighted area in Reach 3, there is a wide, backwater which slows the creek down provides perfect conditions for parrot’s feather to grow and creates a 100% covered area.

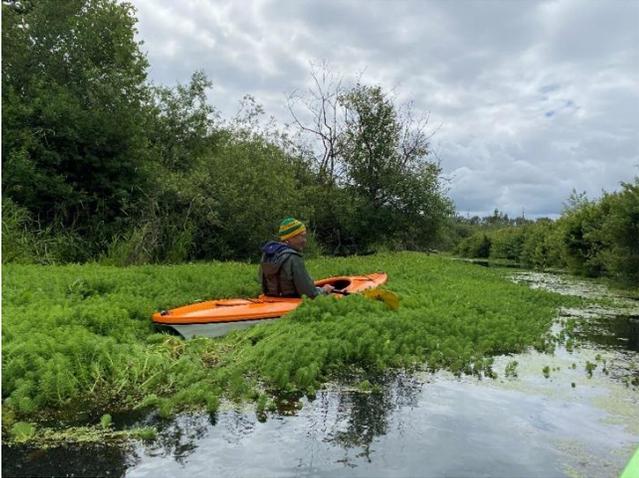
Photo 1: Typical parrot's feather growth in Reach 1 covers most of the channel. June 2023

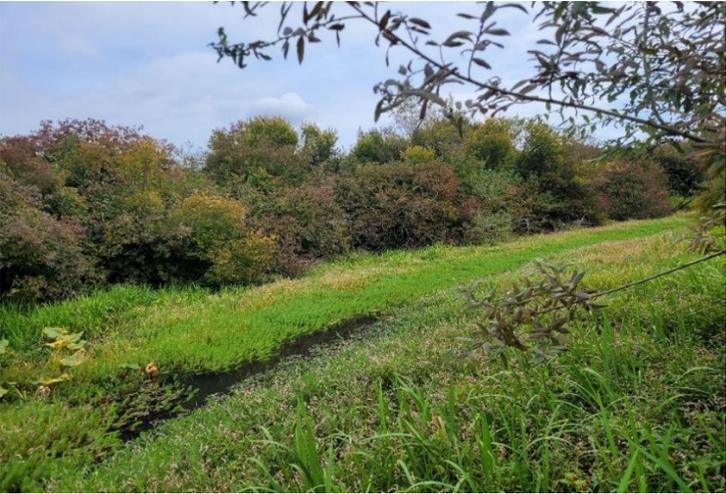
Photo 2: Typical parrot's feather growth in Reach 2 spans entire channel in multiple sections. September 2023

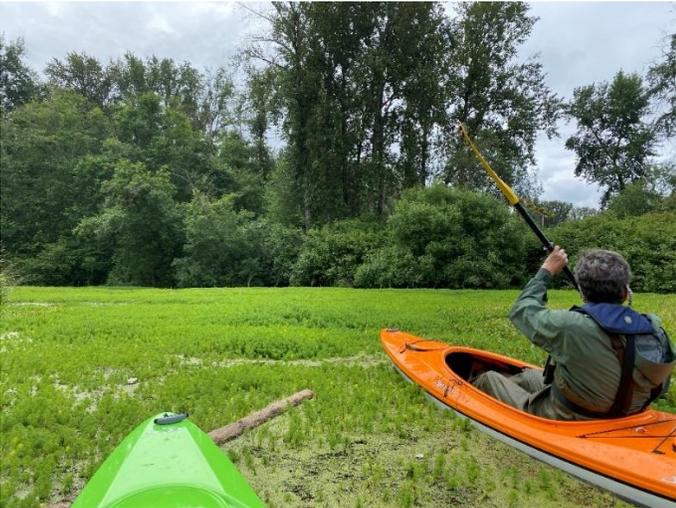
Photo 3: downstream view of typical parrot's feather coverage in Reach 3 that spans the entire channel within Cowichan Tribes land. June 2023

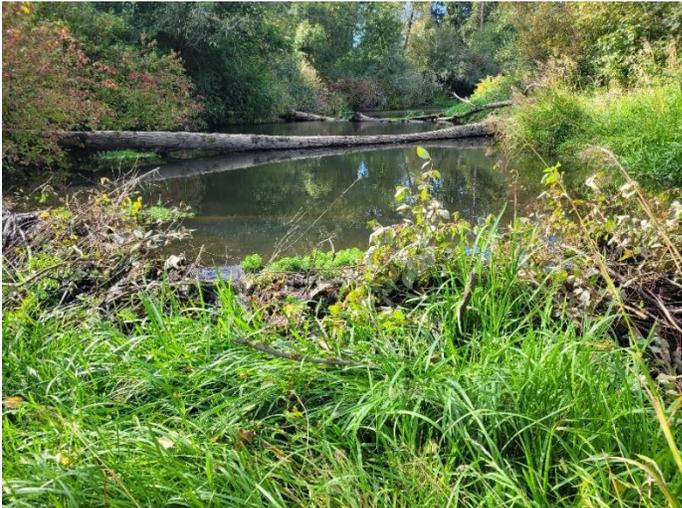
Photo 4: Upstream view from Beaver dam at the end of Reach 3 shows water levels are still low in October, 2023

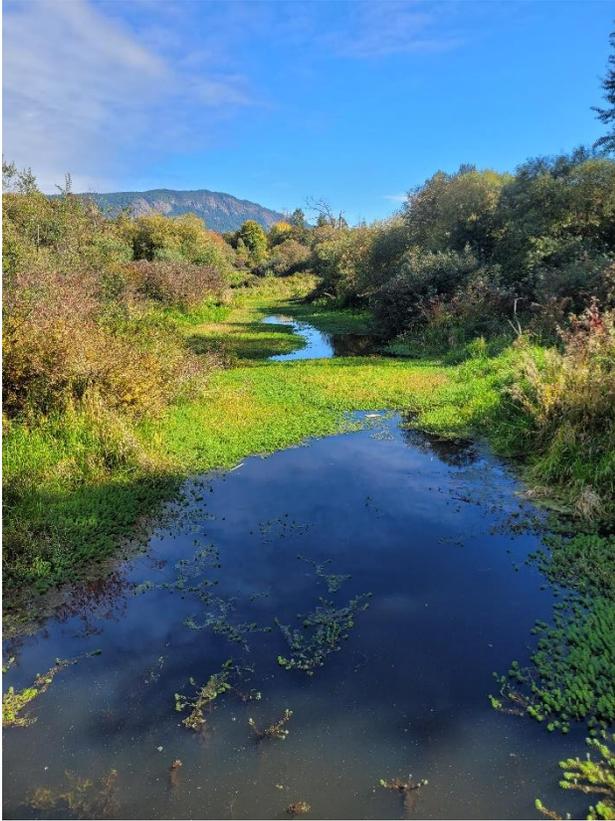
Photo 5: Upstream view from Tzouhalem Bridge, Reach 3, shows growth in June, 2023.

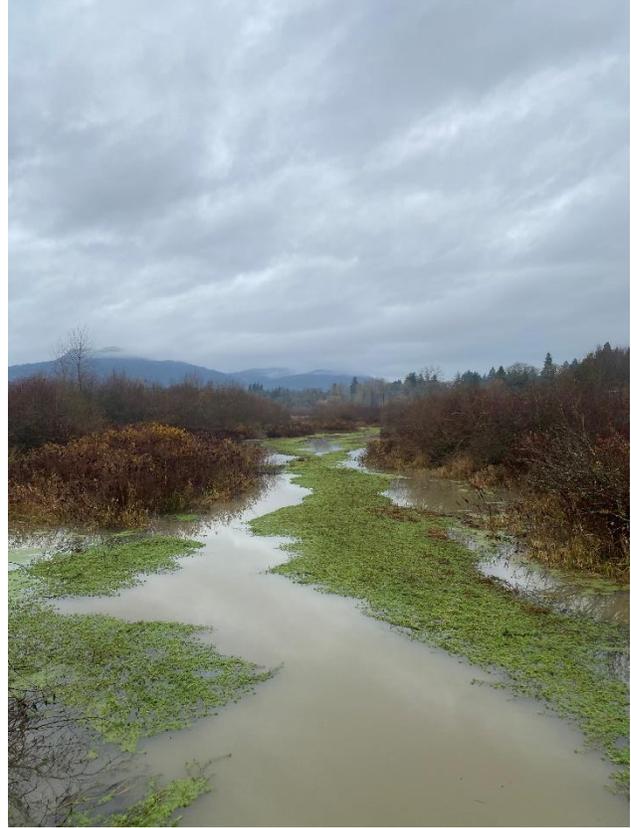
Photo 6: Upstream view from Tzouhalem Bridge, Reach 3, shows dying parrot's feather being pushed downstream in higher flows in December, 2023

Mats of parrot's feather in the creek may present annual physical and water quality barriers to fish migration until fall break-up occurs, and fall rainy season begins. At that time, high flows will cause the parrot's feather to die off and get flushed down the creek, into Cowichan River and out to the ocean.

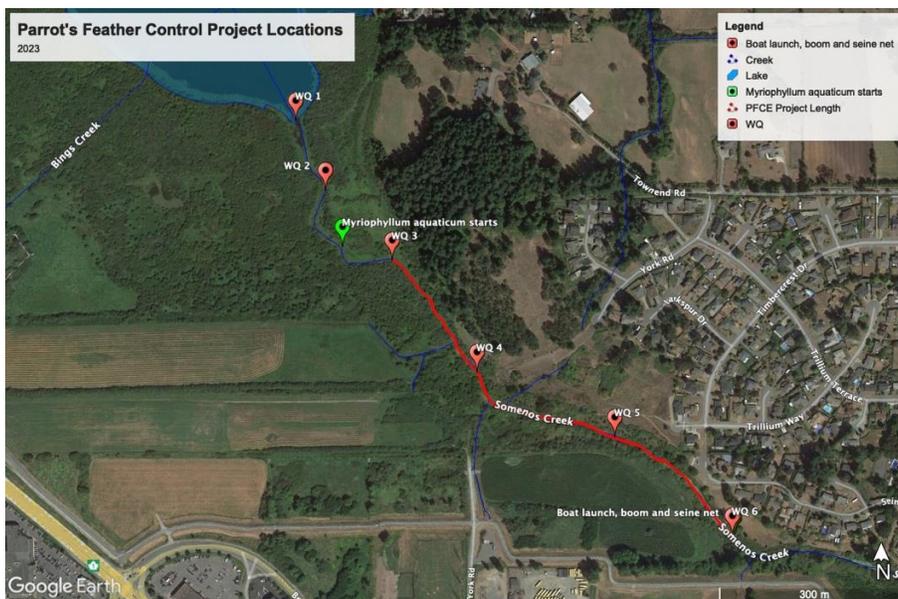
FIGURE 4: MAP OF PFC ACTIVITY LOCATIONS IN SOMENOS CREEK.

The Parrot's Feather Control project took place in Somenos Creek extending downstream from where *M. aquaticum* is established for a total distance of 600m (Figure 4). This area was chosen due to its accessibility both by road to the Creek, and the presence of an open field which was used to dry the *M. aquaticum* after it was removed from the Creek. The Society conducted parrot's feather clearing operations 300m from the head of the creek as a precaution against spreading parrot's feather to the lake. Surveys by the Society in 2021 and 2022 show that the dense growth of other aquatic plants, especially Water Lily (*Nuphar polysepala*), and Smartweed (*Polygonum* spp.) at the head of the creek appear to be a barrier to the spread of Parrots Feather to the lake. The section of Creek in which the project took place is relatively wide, measuring about 4-5 meters in some sections, with few sections any narrower than 3 meters during the dry season. The banks are quite steep, and the water is approximately 1.5 to 2 meters deep. The Creek has very limited observable flow, if any, during dry summer months (Preikshot, 2019) easing boat use and clearing operations. The main barrier to movement within the Creek was overhanging vegetation along the banks and the *M. aquaticum* and other aquatic vegetation which established quickly in the Creek.

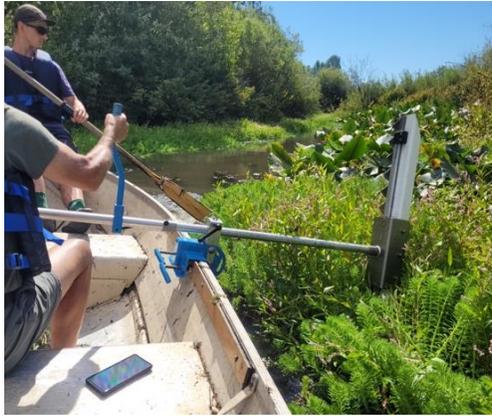
Photo 7: The aquatic mower in action on Somenos Creek.

The aquatic mower was mounted on the right side of the boat onto the reinforced gunwale (photo 7) which meant that the NE side of the Creek was cut while moving upstream and the SW side while moving downstream. Originally the proposal was to limit the cutting to the leading edge of the *M. aquaticum*; however, as the PFC did not begin until late June, there were sections where larger clumps had to be cut off in order to create and maintain a channel.

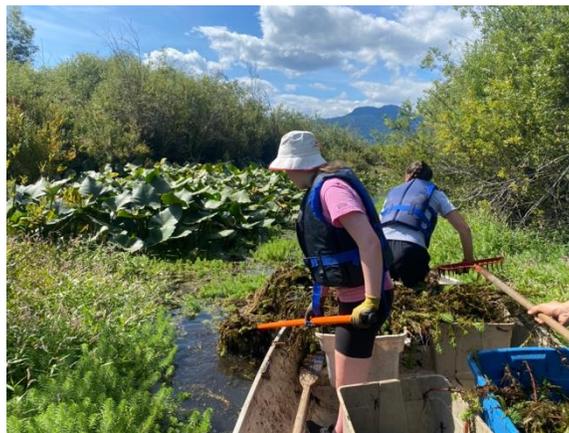
Photo 8: Parrot's feather collection in Somenos Creek.

The team would work their way upstream in the boat, stopping to collect the cut *M. aquaticum* which floated freely in the Creek. It was collected in the boat in 5 large totes, (photo 8) which, once full of *M. aquaticum* would then be hauled out of the creek and dumped out on the greenway to dry. Most of the *M. aquaticum* was spread out about 20cm thick while some was left in a pile to determine which method was most effective at killing the plant over the summer and winter months.

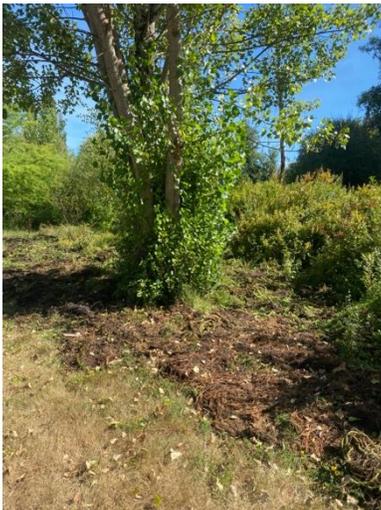
Photo 9: Parrot's feather pile at the end of August, 2023.

The Society removed, in total, 15.191m³ of *M. aquaticum* from Somenos Creek over the duration of the PFC, as measured by 194 mid-sized storage totes. This material was dumped and spread out on the park greenway near the boat launch site (Photo 9), and some was piled in another area to compare results. The *M. aquaticum* dried well over 2 months in the summer heat having a crispy consistency that fell apart when crushed; however, it was observed that some of the *M. aquaticum* began sprouting as soon as the wet season began in September (Photo 10). It is surmised that even though the layer of *M. aquaticum* was laid out to dry in a thin layer of 20cm, not all of it dried and would have needed more time to fully desiccate. Half of the *M. aquaticum* that was laid out to dry was turned over in September to discern if flipping it may make any difference in the drying process, no discernable difference was observed and *M. aquaticum* continued to produce new growth after being flipped. After observing the *M. aquaticum* piles until December, it was noted that most of the plant had turned black/brown and appeared to be dead, with only one observable still green plant (Photo 11). The society found that both the spread-out *M. aquaticum* and the pile had significantly decomposed by mid-December, which demonstrates that both methods were effective at killing the plant. The *M. aquaticum* will continue to be observed through the winter.

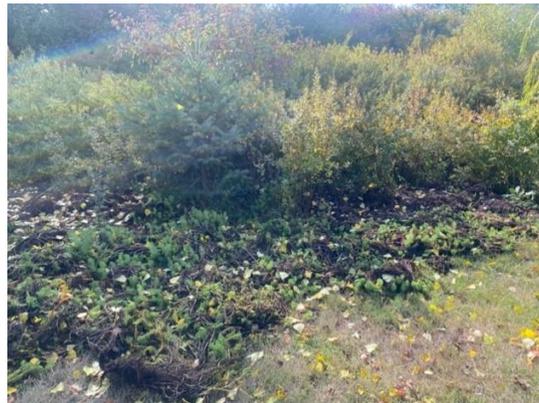
Photo 10: Parrot's feather pile, on September 29th 2023.

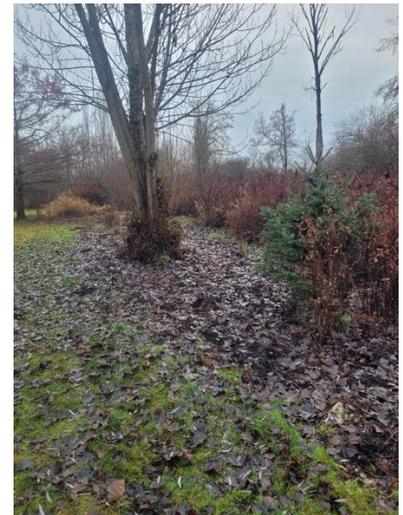
Photo 11: Parrot's feather pile December 18th 2023.

After observing the *M. aquaticum* that was left on the greenway to die it was noted that both spreading the plant out and piling it proved effective in killing it. But, with consideration of removing more volume and expanding the project length in 2024 it has been shown that piling it will be the most effective. This option will reduce the need for larger open areas to dry the removed *M. aquaticum* which would be difficult to locate farther down the creek. The other option would be to truck the *M. aquaticum* off site and compost it somewhere else. However, the effectiveness of trucking may be limited by the ability to safely transport the cut *M. aquaticum* and the ability to locate a suitable site to compost it. In communications with DFO staff, this could be an option if a plan is provided for approval.

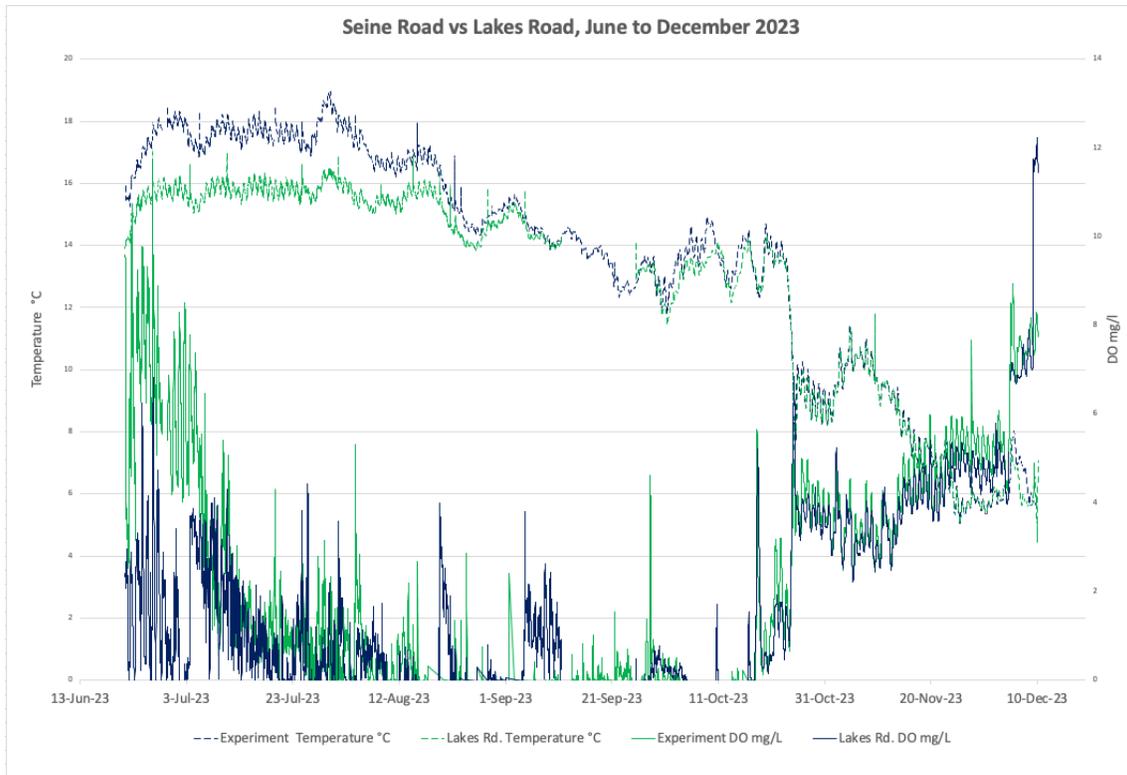
CHART 2: PROJECT VS CONTROL DISSOLVED OXYGEN AND TEMPERATURE FROM BEGINNING OF PROJECT TILL MID-DECEMBER.

similar to previous years (2020-2021). Spawning salmon were not seen earlier than November 23, 2024 due to unfavorable water quality conditions in Somenos Creek before this date (Section 5.3.3 Chart 2).

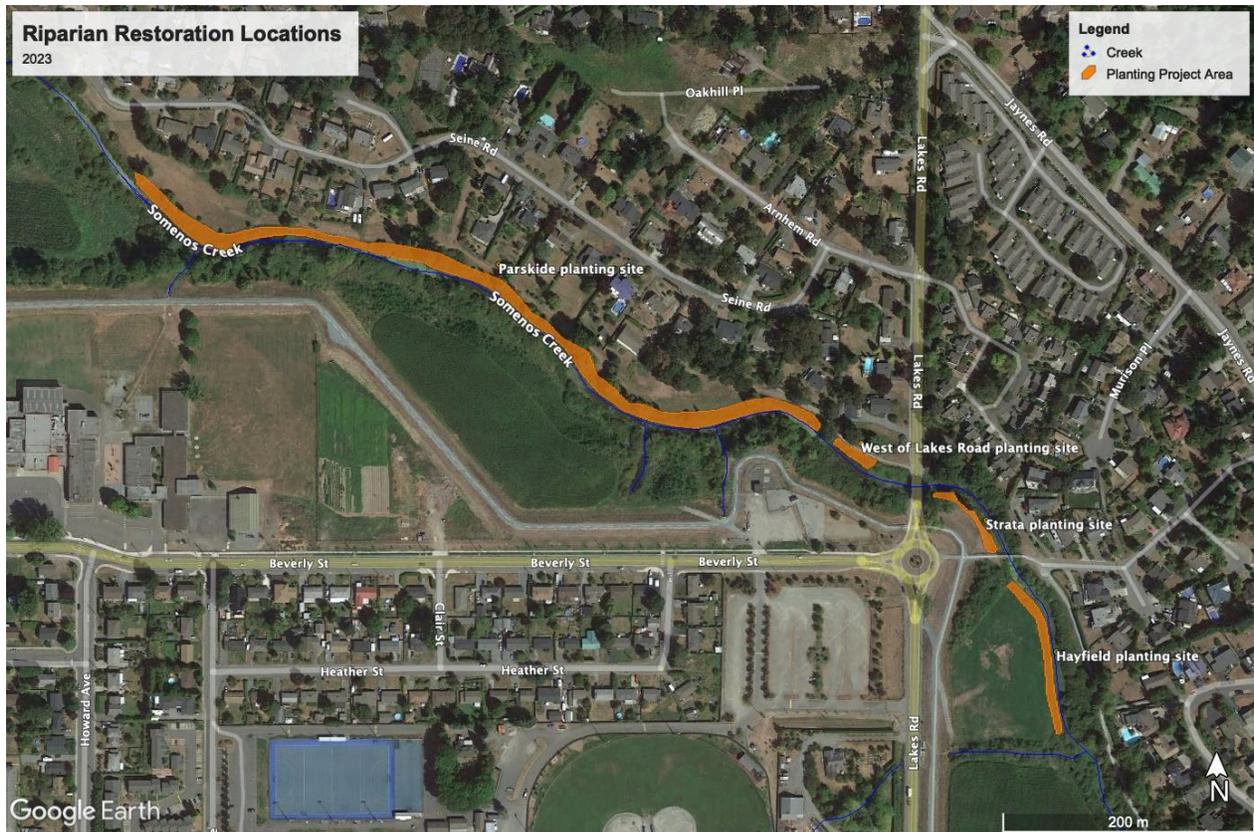
FIGURE 5: MAP OF FOUR LOCATIONS WHERE RIPARIAN PLANTING WAS DONE IN 2023.

1. The hayfield south of the Lakes Road footbridge (hayfield).
2. The open section on the north side of Somenos Creek, just west of Lakes Road (west of Lakes Road)
3. The southwest side of the Haycroft Chase Strata Property and MNC Right of Way (strata)
4. The north side of Somenos Creek along the municipal park between Lakes Road and Seine Road (parkside).

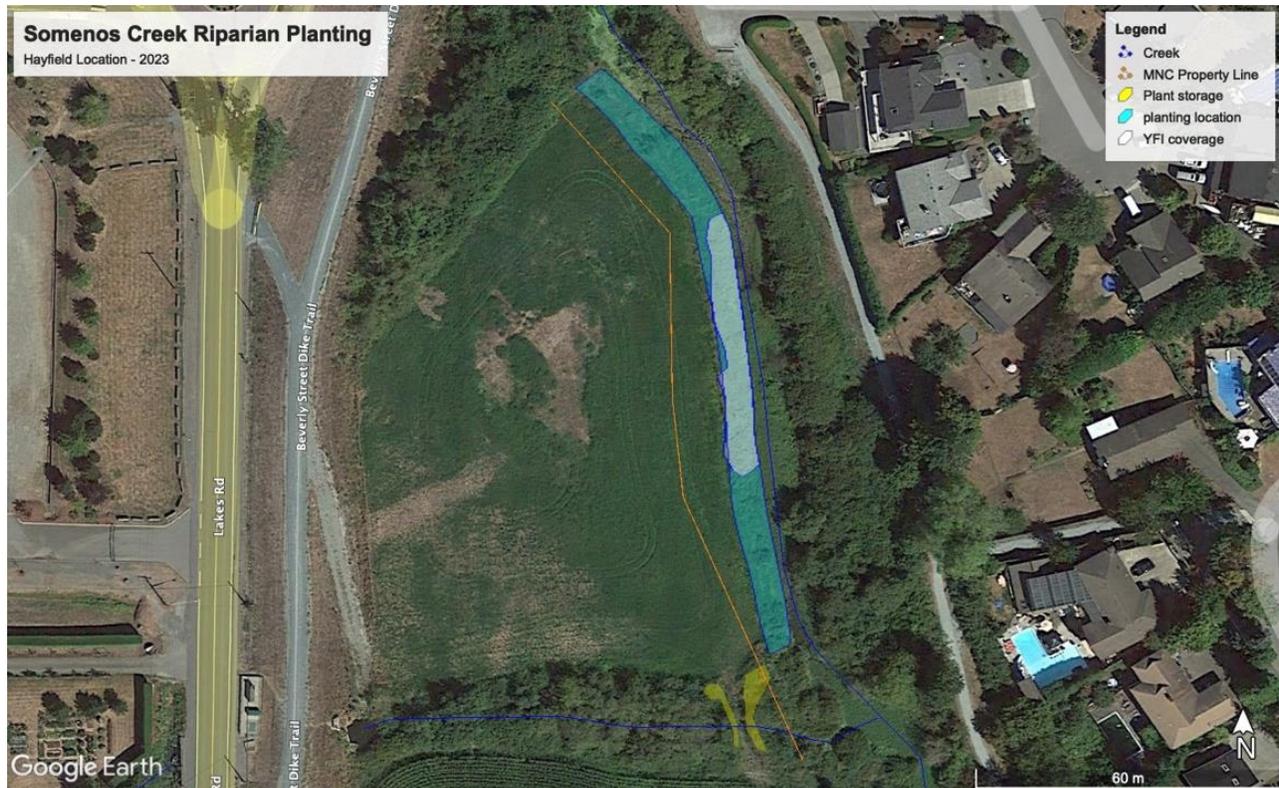
FIGURE 6: MAP OF HAYFIELD PLANTING LOCATION WITH MNC PROPERTY LINE AND PLANT STORAGE AREA.

In April three site visits with SMWS, MNC and the Farmer (Aaron Van Boven) were completed to confirm the MNC right of way and the planting area, the area agreed upon is shown in Figure 6 below. Based on the meetings with the MNC, Aaron Van Boven and additional correspondence with Greg Howard (Madrone), the planting plan was updated to consider the change in area.

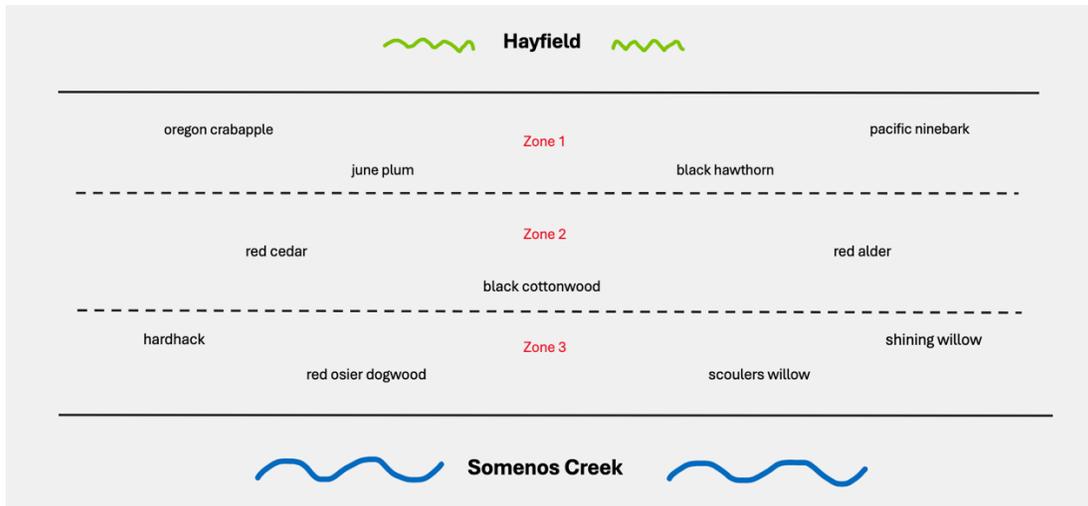
FIGURE 7: GRAPHIC SHOWING ZONES OF RIPARIAN PLANTING AT HAYFIELD ON SOMENOS CREEK.

Site prep began the first week of May 2023 and planting commenced on May 4th, large posts delineating the planting area were installed and planting began on the southern section of the Hayfield. Yellow flag iris (*Iris pseudacorus*) was present on site, see figure 6, and some removal was done, however, this proved futile due to the amount that was present, reed canary grass (*Phalaris canariensis*) was also present on site, particularly in the northern section, this was mowed down to allow for easier access. Plants were planted one plant per square meter which follows the riparian restoration rule of thumb (DNV, date unknown), and suggestions from Greg Howard, where vegetation was already established, new plants were planted one meter away. Based on suggestions in the Madrone report and requests from the Farmer, a planting zone system was established: shorter, drought resistant shrubs and trees were planted closest to the hayfield (zone 1), tall trees were planted in the middle (zone 2) and shorter wetland plants were planted along the bank (zone 3), see figure 7.

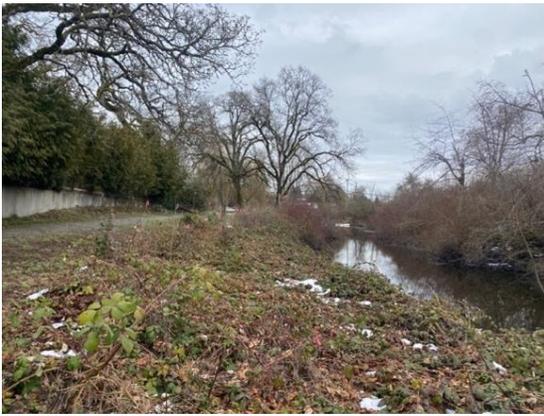
Photo 14: Image of planting area looking east, before invasive removal.

After an initial site visit on March 1st, 2023, invasive removal began on March 2nd, with three clearing events 274m² of Himalayan blackberries and field bindweed were removed (Photo's 14 & 15). The site was then left for the spring to allow any remaining alive trees to grow as survival rates were not determinable before spring regrowth. On July 26th another site visit was completed, it was noted that none of the native trees had survived, and the invasive plants had somewhat regrown. From July 26th till August 31st the invasive plants were removed, the removal mostly focused on getting the blackberry roots out to ensure a better success rate, totaling about 100m² (photo's 16 & 17), then 64 native trees and shrubs were planted, see Appendix G, Table 4 for full list. Mulch was also spread around the base of the planted trees to ensure the soil was protected after having all vegetation removed. Planting methods followed those used at the hayfield, described in Section 6.3.2. Watering occurred one to three times a week during the dry season.

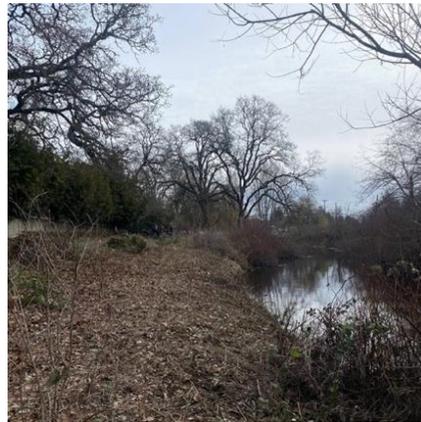
Photo 15: Image of planting area looking east, after invasive removal.

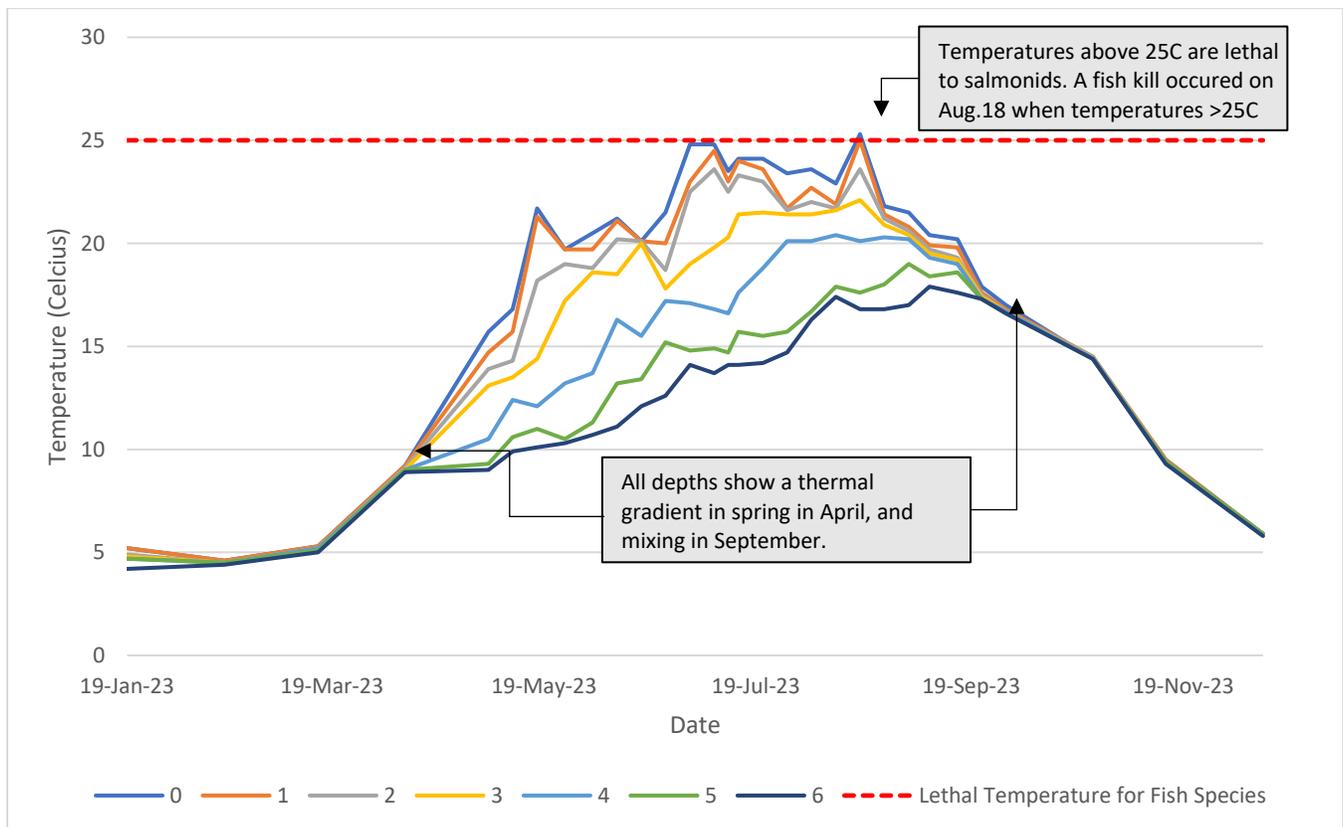
Chart 1 Somenos Lake Temperature YSI Depth Profile of Surface to 6 m, 2023.

Dissolved oxygen and temperatures indicated that stratification occurred in early April and turned over by late September (Chart 1 and 2). Interestingly, in late September when mixing occurred, dissolved oxygen dropped dramatically throughout the lake. This likely occurred when the anoxic conditions at the bottom of the lake mixed with the top layers and created low oxygen environment throughout. This low oxygen event didn't last long and by October the lake oxygen levels normalized as fall rains and cool temperatures began.

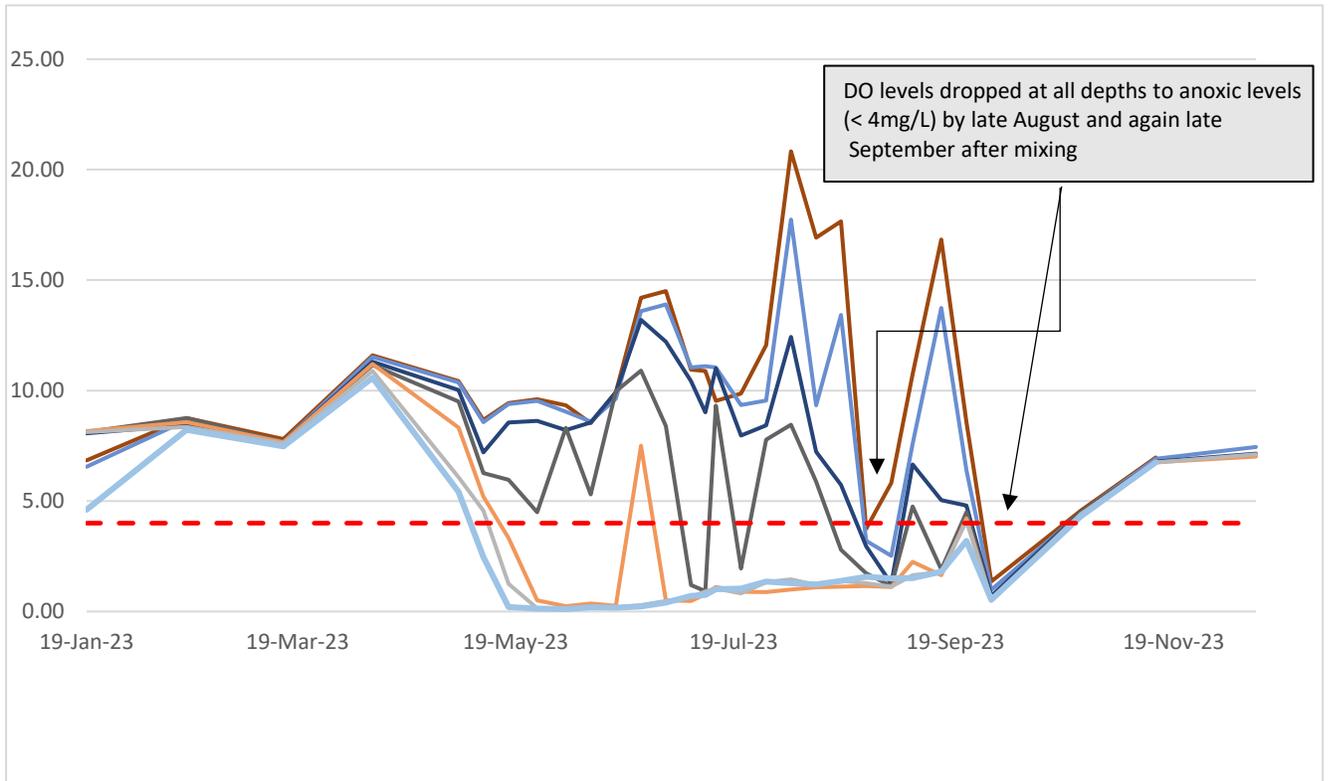
Chart 2: Somenos Lake Water Quality Profile of Dissolved Oxygen, 2023

One main importance of thermal gradient observations is to determine where pockets of adequate temperature and dissolved oxygen levels exist in the lake, allowing fish to survive. Salmonids are known to use Somenos Lake as a migratory pathway and a refuge; however, fish kills have occurred in the past due to summer anoxic conditions. Their dissolved oxygen thresholds range from: anoxia 0-4 mg/L; hypoxia 4.1-7 mg/L, sub-optimal 7.1-10 mg/L and optimal oxygen above 10 mg/L (Davis 1975). Salmonids consistently avoid concentrations below 6mg/L (Carter 2005).

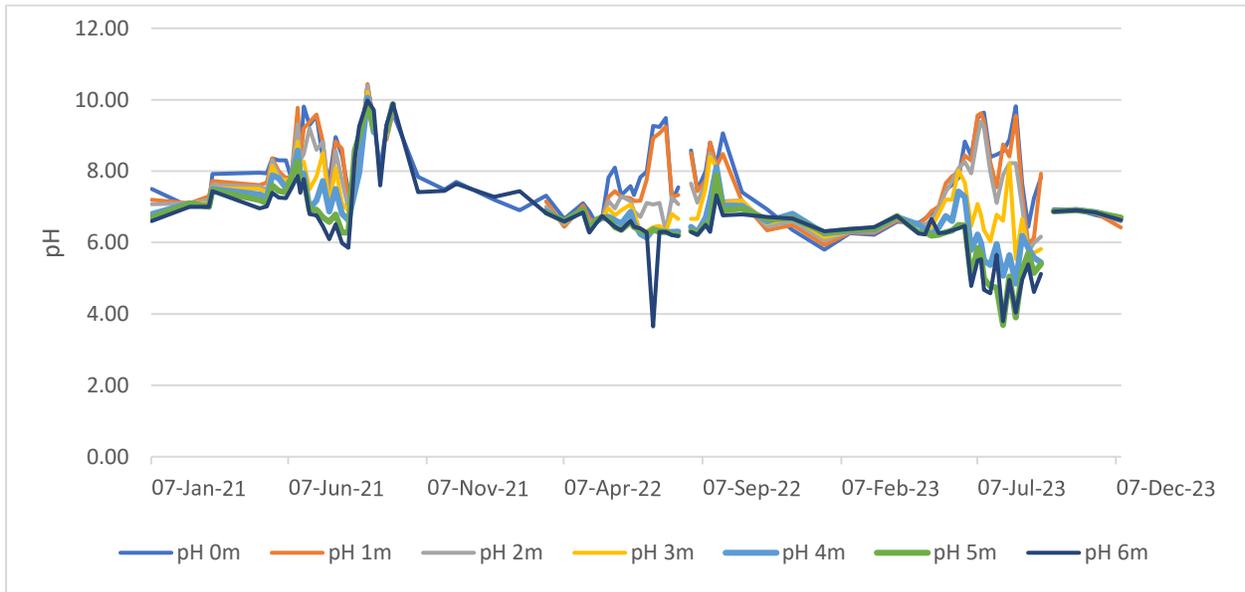
Chart 9: Somenos Lake pH YSI Profile Levels, 2021-2023

Similar pH results are observed in 2021 to 2023 showing an increase in acidification at the deepest depths, and high alkalinity at the surface in summer (Chart 9).

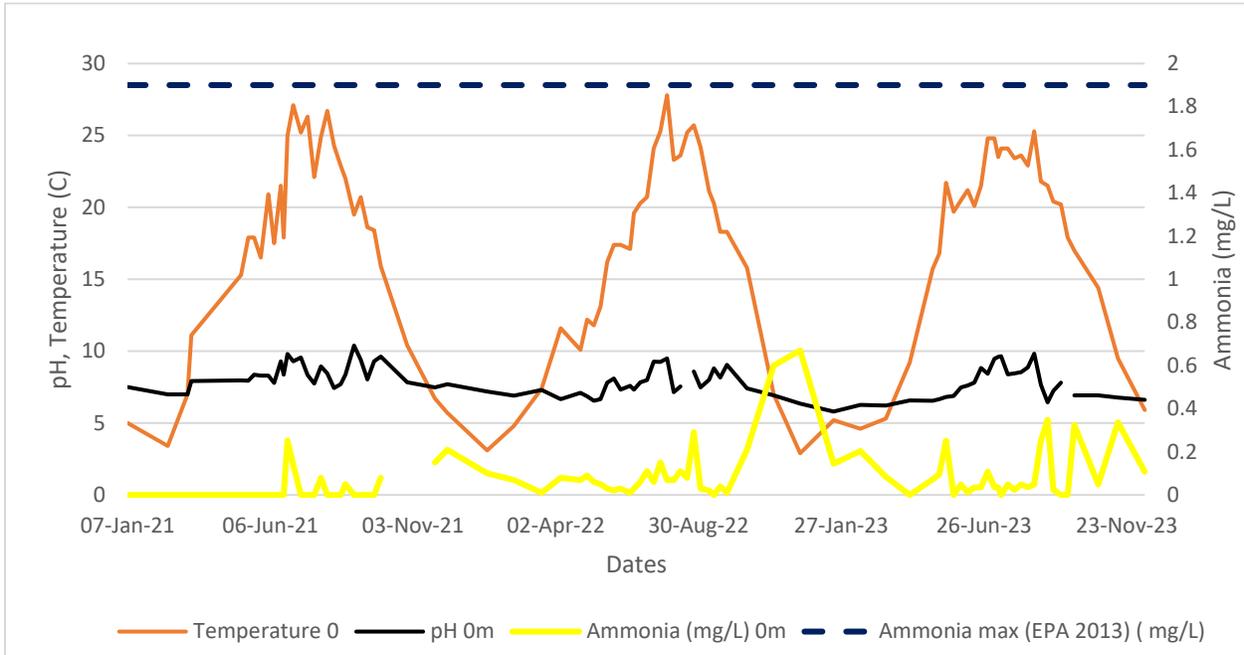
Chart 10: Somenos Lake pH, Temperature (C), and Ammonia Surface Levels, 2021-2023

A major factor to consider when monitoring pH is that ammonia toxicity increases with more alkaline water, which occurs on the surface in summer. In the summer at the lake surface, when pH was between 8-9, ammonia levels did not exceed guidelines (1.94 mg/L BCMOE, 2023) (Chart 10). Thankfully where alkalinity is high at the surface, the concentrations of ammonia were low, which is likely due to high algae activity (blooms) in the epilimnion in summer (Chart 10).

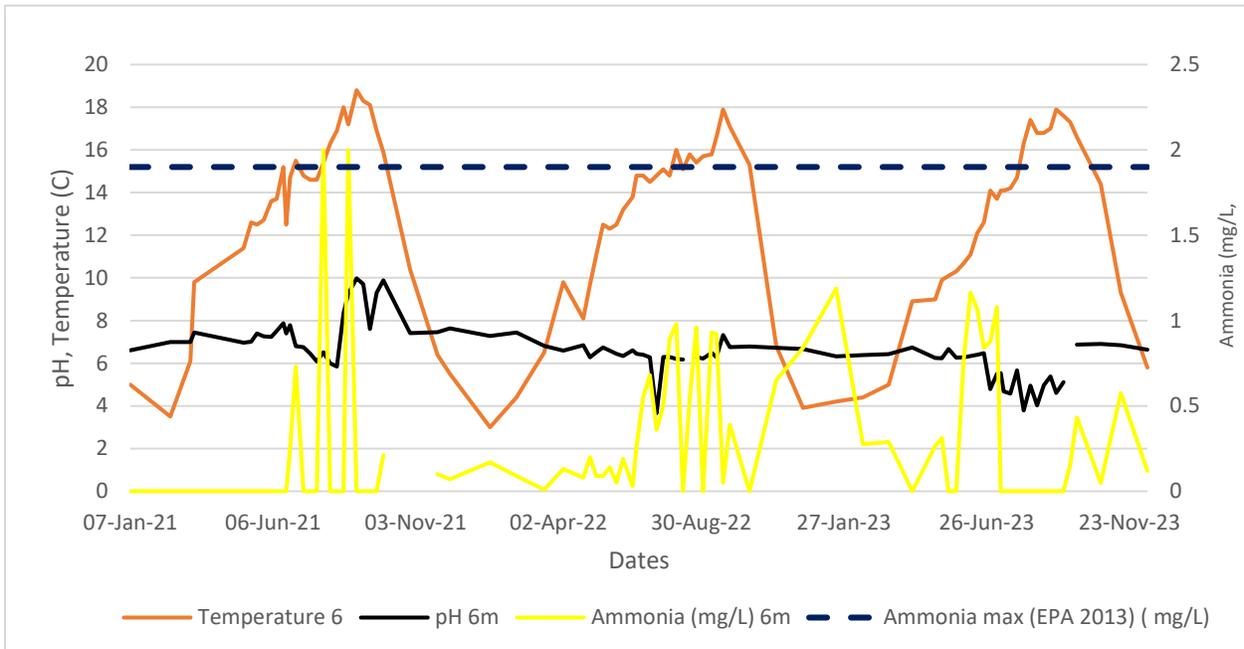
Chart 11: Somenos Lake pH, Temperature (C), and Ammonia Bottom (6m) Levels, 2021-2023

Conversely, at the lake bottom the pH is low (more acidic), which can reduce ammonia’s toxicity. This is seen at 6 m depths (Chart 11) in summer when pH decreased to a range of 3.8-6, and ammonia guidelines were not exceeded (approximately 1.81 mg/L, BCMOE, 2023) in 2023. However, in 2021 there may have been exceedances of ammonia (2mg/L) in late August, when temperatures peaked at 6m, and pH was alkaline. At this high alkalinity exceedance limits would be ~ 1.97mg/L. Due to this, in late summer early fall during peak bottom temperatures turn-over will be closely monitored for future exceedances.

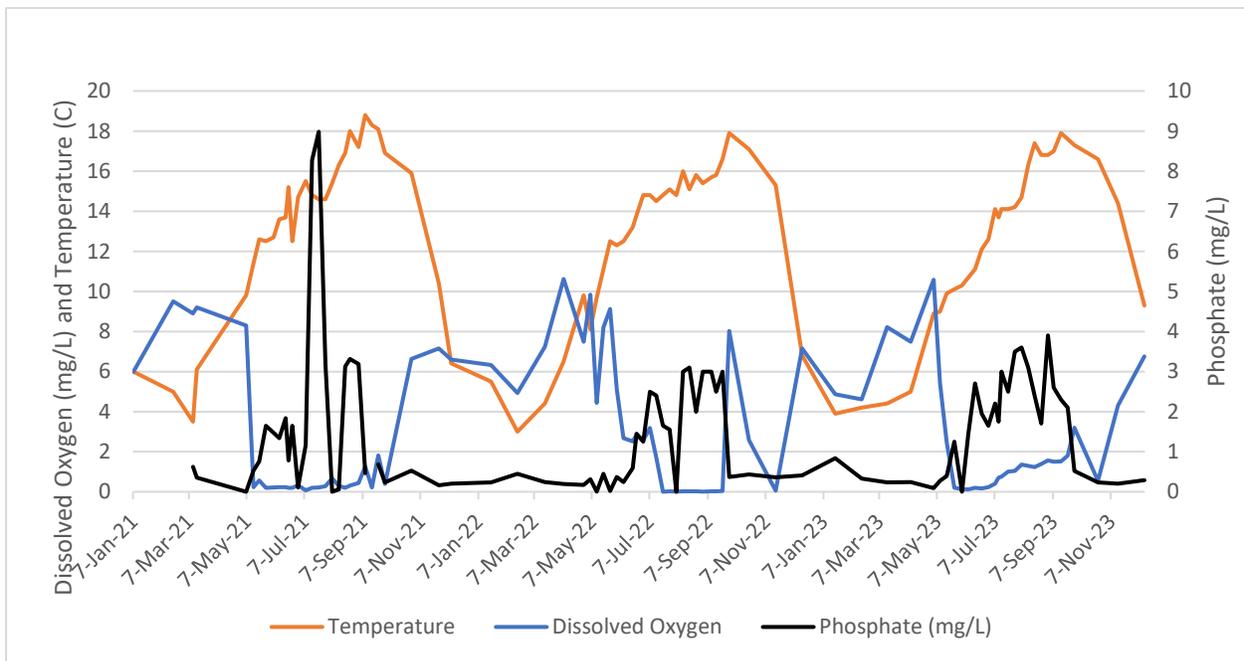
Chart 13: Somenos Lake total phosphate, temperature and dissolved oxygen at the bottom from 2021-2023

Chart 13 shows the relationship of phosphate, temperature and dissolved oxygen levels at the bottom of the lake. It is observed that phosphate is released from the bottom of the lake as summer approaches when temperatures rise, and dissolved oxygen declines. Increased temperatures in summer initiate a release of phosphate from the sediment (Schindler and Vallentyne 2008), feeding algae growth on the surface, and microbial activity. When excessive organic matter from algal blooms sinks to the bottom, it is decomposed by microbes, creating an anoxic environment at the bottom, which is why we see a decline in dissolved oxygen. As fall approaches, temperature and phosphate levels drop, reducing growth and decomposition (Schindler and Vallentyne 2008), allowing dissolved oxygen to recover.

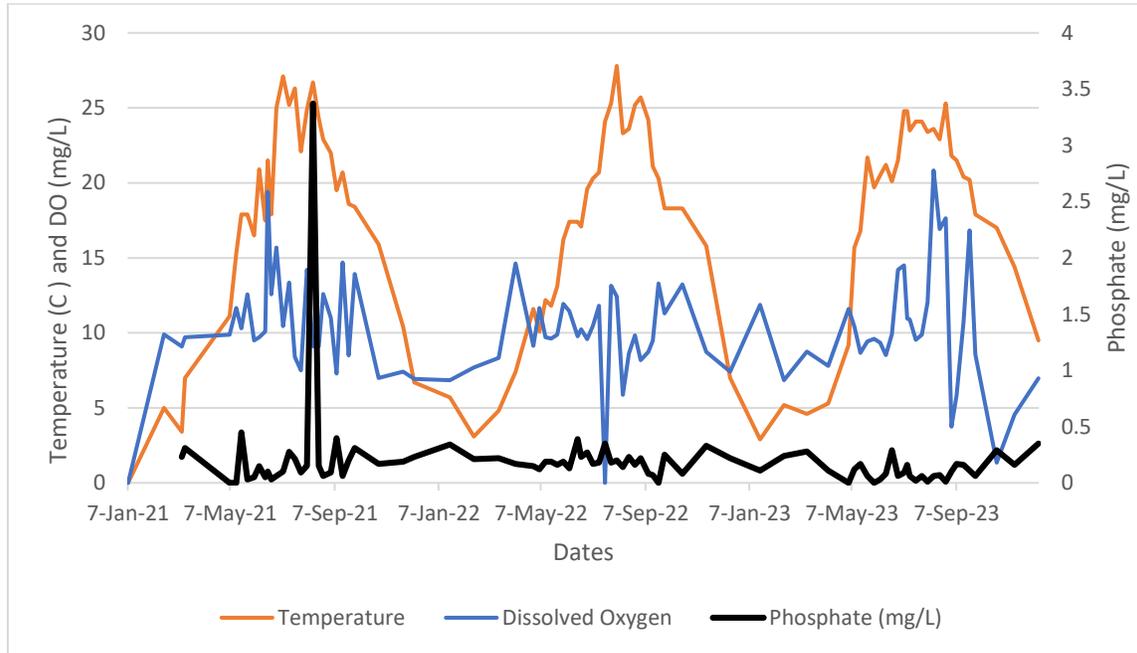
Chart 14: Somenos Lake total phosphate, temperature, and dissolved oxygen at the surface, 2021-2023

Phosphate is low at the surface because it is consumed by algae blooms during the growing season. The algae will then produce more oxygen at the surface as seen in Chart 14.

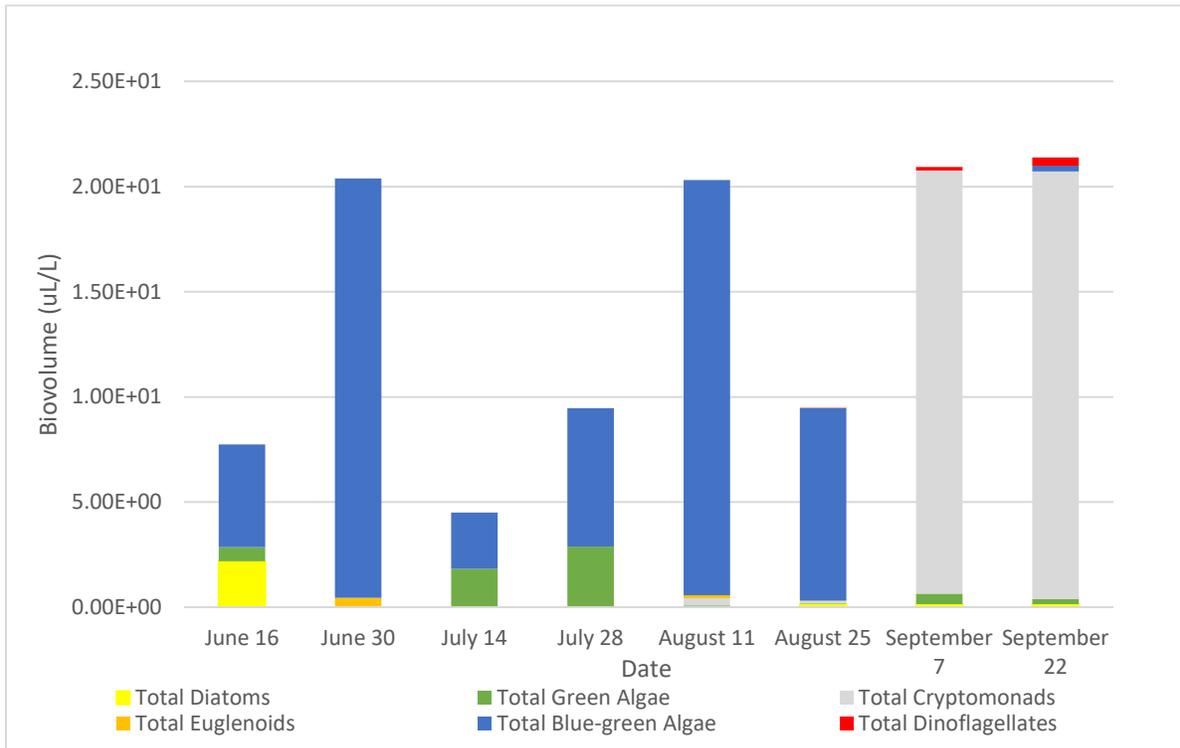
Chart 16: Somenos Lake Phytoplankton Community Bi-Monthly Abundance, 2023

There is also a notably large population of green algae that blooms during the hot months of July, however only secondary to the blue-green algae. After the blue-greens die off in September, Cryptomonads dominate the community profile (Table 1, Chart 16). Due to the high recreational use of the area the high blue-green algae is a concern since some species produce toxins that can kill wildlife and may be harmful to humans.
