Prepared By Gina Hoar, R.P.Bio.,
and Phaedra Douglass, BA.

MUNICIPALITY OF NORTH COWICHAN SERVICE
AGREEMENT WITH THE SOMENOS MARSH
WILDLIFE SOCIETY
ANNUAL REPORT 2023

Prepared for: Municipality of North Cowichan

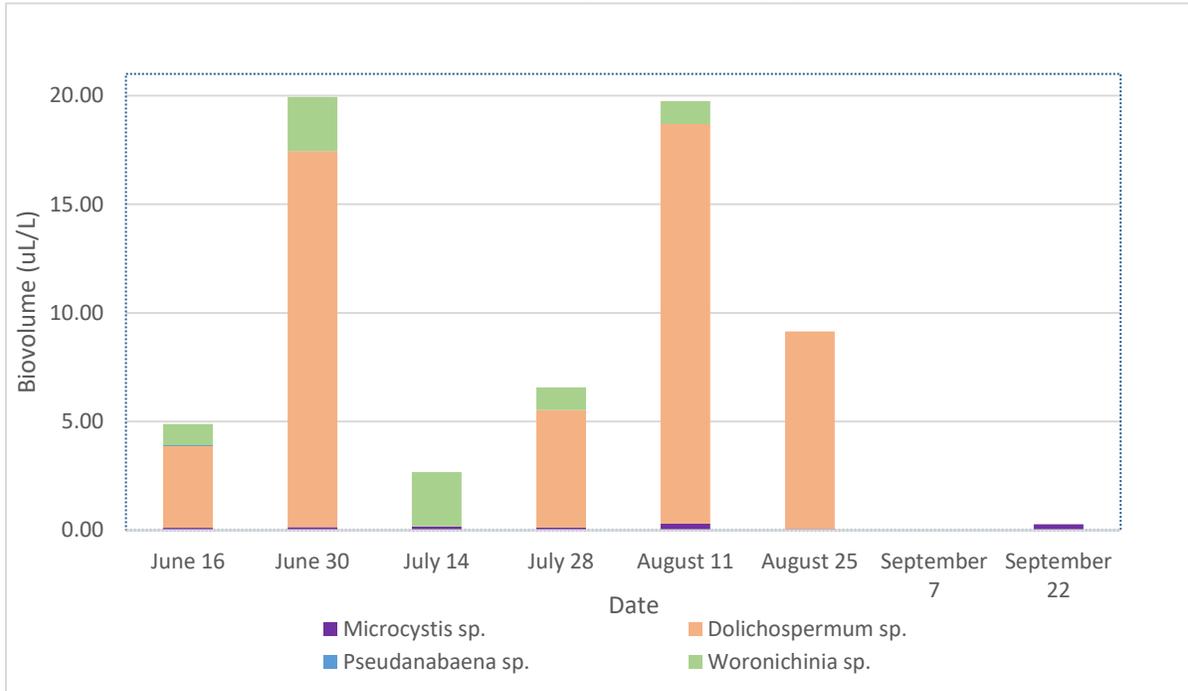
Chart 17: Somenos Lake Blue-Green Algae Bi-Monthly Species Abundance, 2023

In summer, the blue-green algae community was predominately *Dolichospermum* (formally *Anabaena*), followed by *Woronichinia*, *Microcystis* and lastly *Pseudanabaena* species, which was only present early June. By late September, the blue-green algae community was reduced to only *Microcystis* (Chart 17, Table 2). *Microcystis*, *Dolichospermum*, and *Woronichinia* are all considered to be problematic and produce various toxins (Rosen, et. Al 2015).

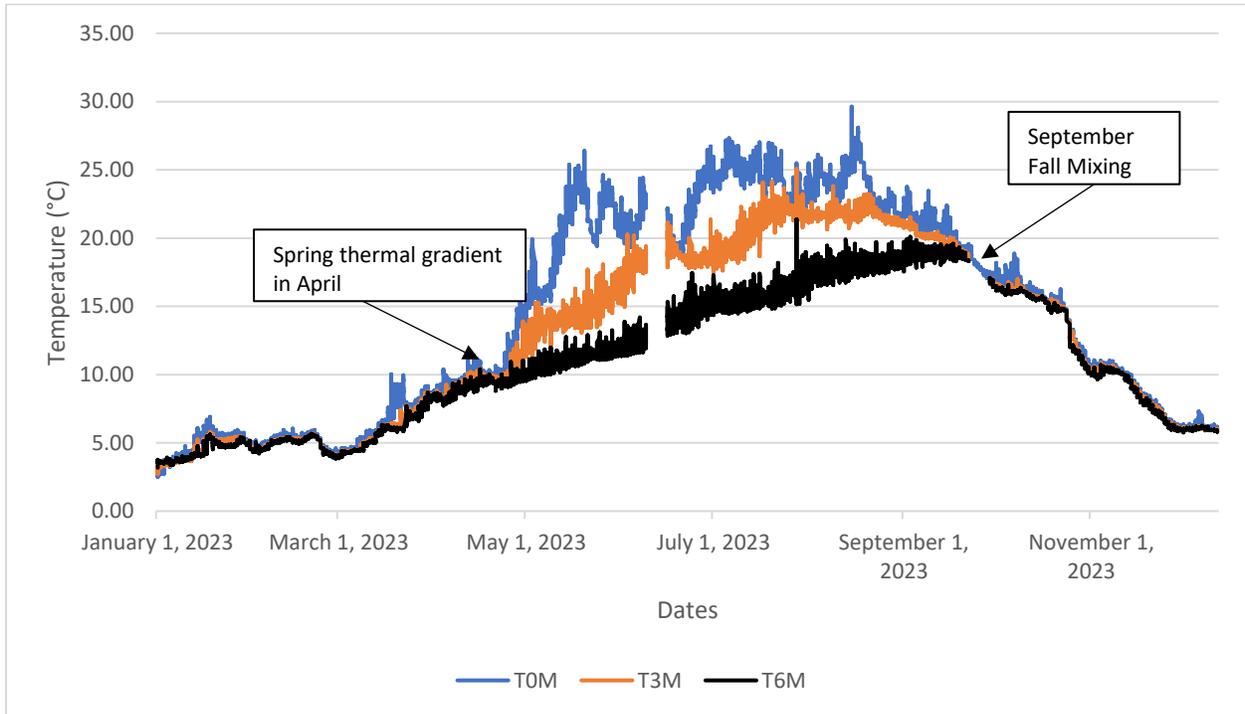
Chart 20: Somenos Lake Temperatures recorded at surface, middle, bottom of the lake, 2023.

In 2023, data loggers (tidbit hobos) were deployed in Somenos Lake to measure hourly temperatures at the surface, 3m and 6m depths (Chart 20). Generally, the surface temperature (0m) is warmer than at 3m, and 6m depths are colder than the upper layers during the warmer months when it was stratified. When turnover occurs in fall you can see when temperatures at multiple layers mix and become similar.
