**LOWER BINGS CREEK RESTORATION 2000:
A REPORT**

By
Ted Burns
Biologist

For
Somenos Marsh Wildlife Society and Nature Trust
September 10, 2000

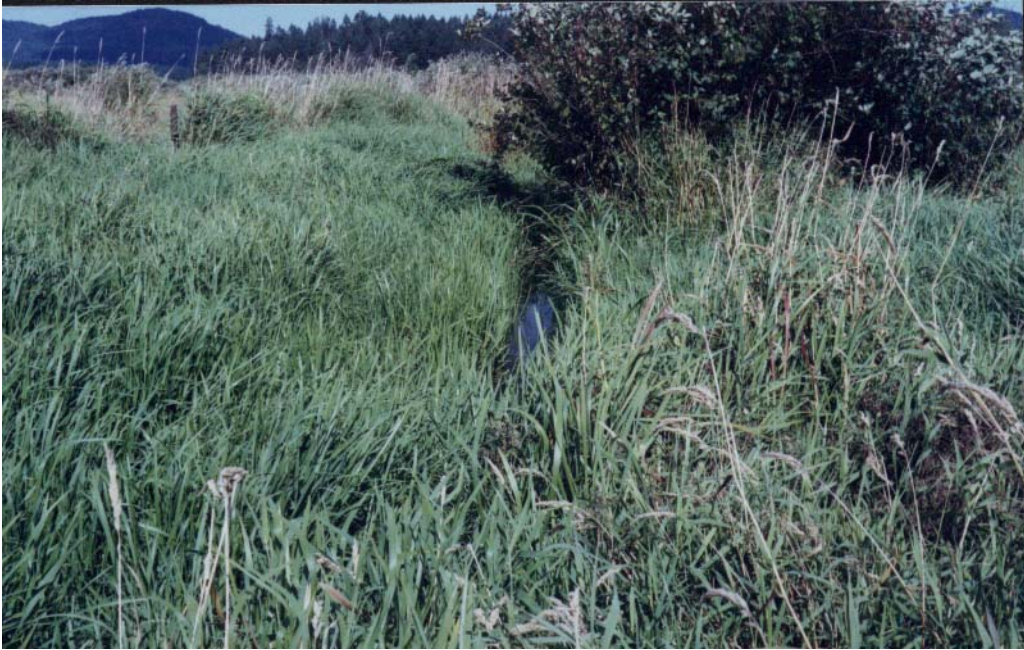
Photo 1: The channel was choked with Reed Canary Grass and Carex

Much of Lower Bings Creek (Reaches 1 and 2) had become choked with Reed Canary Grass. Channel width in the target section had decreased from a mean of 6-7 m to an average of 1.18 m since the mid-1980's due to Reed Canary Grass encroachment from the sides. Reed Canary Grass became established many decades ago when lower Bings was cleared and ditched for agricultural purposes. The channel's flow capacity was reduced and several breakout channels had established along the left (north) bank. Bedload build up had also occurred due to increased channel constriction and beaver activity and the creek was spilling into the field to the north at flows greater than 40 LPS. Flows above this level occur for at least nine months per year (WSC, 1990). Reduced flushing was also thought to be at least partly responsible for summer oxygen sags and very high summer temperatures. Oxygen concentrations as low as .025mg/L and temperatures as high as 24° have been recorded in the Lower Bings target section (Burns, 1999).

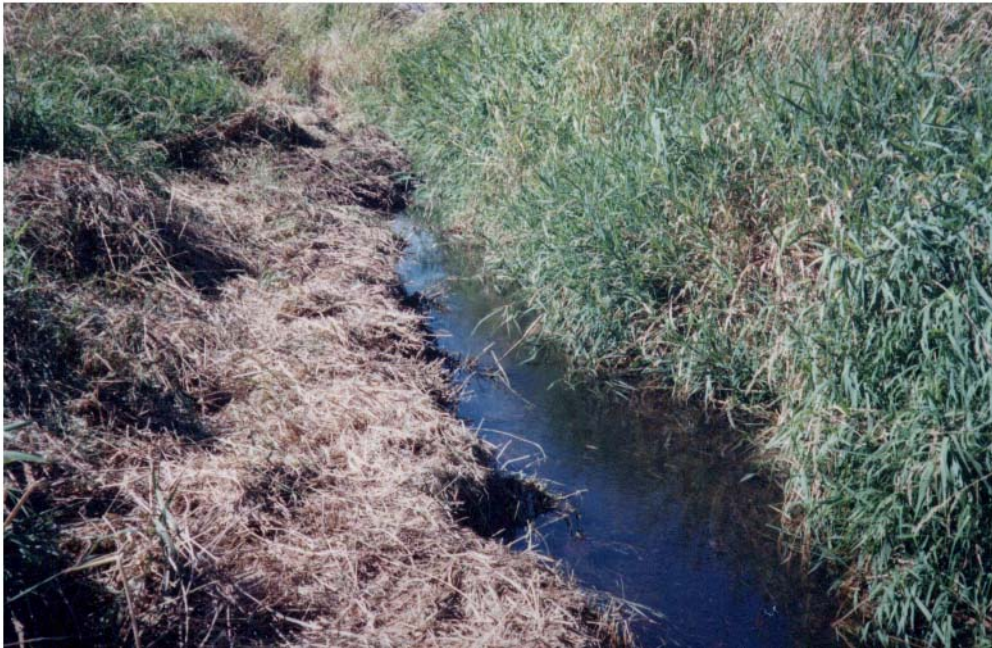
Photo 2: Reed Canary Grass was cut by hand with a scythe or gas powered brush cutters prior to excavation

Prior to excavation, Reed Canary Grass was cut with brush cutters and a scythe so the excavator operator could see the channel. 165 m of channel was excavated between Aug. 30 and Sept. 1, 2000. The treatment area was divided into three sections of 41, 51 and 73 m. The sections were dried by damming them off with sandbag/poly dams and pumping the water around them and the fish were salvaged and released downstream. A total of 130 coho fry between 54 and 90 mm, 13 cutthroat fry and one parr, 168 sticklebacks, 335 sculpins (all *Cottus asper*) and 108 lamprey ammocytes were salvaged. Stop nets prevented the fish from moving upstream. A stop net was also located at the upstream end of each work section. Approximately 1000 m³ of material was removed from the channel. It consisted of Reed Canary Grass sods, muck-detritus and sand-pea gravel. Average channel width was increased from 1.24 m to 7 m, mean wetted width increased from 1.24 m to 2.7 m, and average depth improved from .167 m

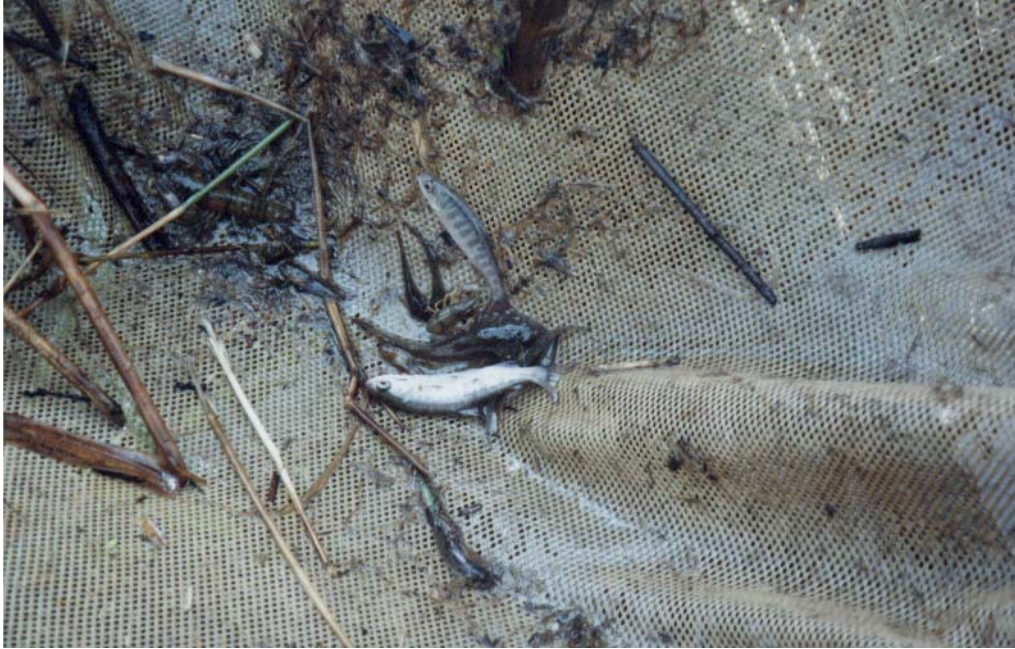
Photo 3: The fish were salvaged as the pumps were drying the sections to be excavated

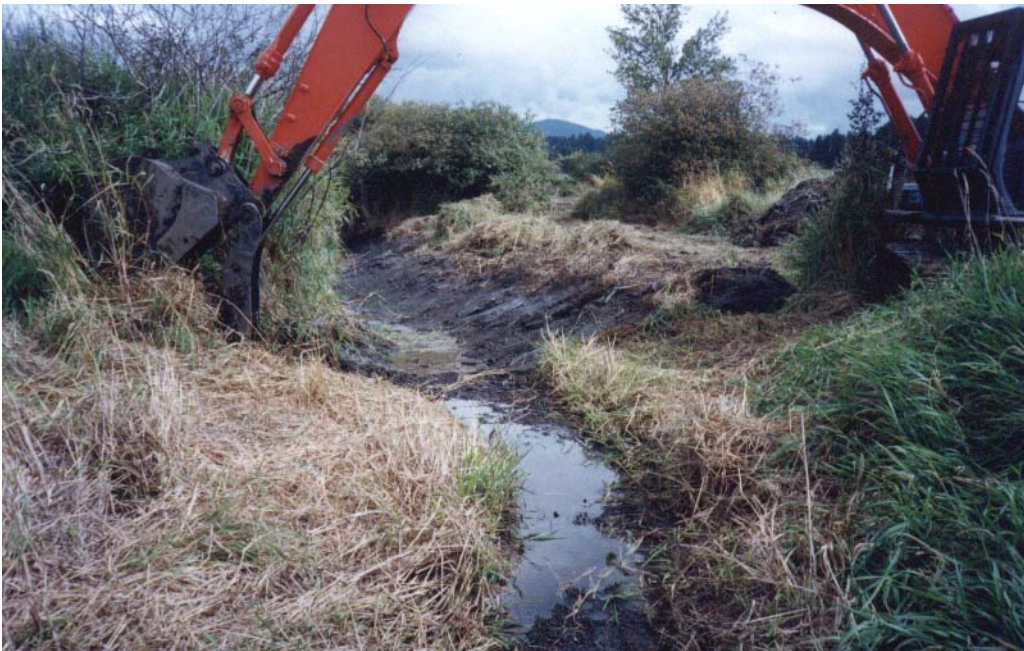
Photo 4: The channel sections were excavated with a 245 class excavator with a cleanup bucket

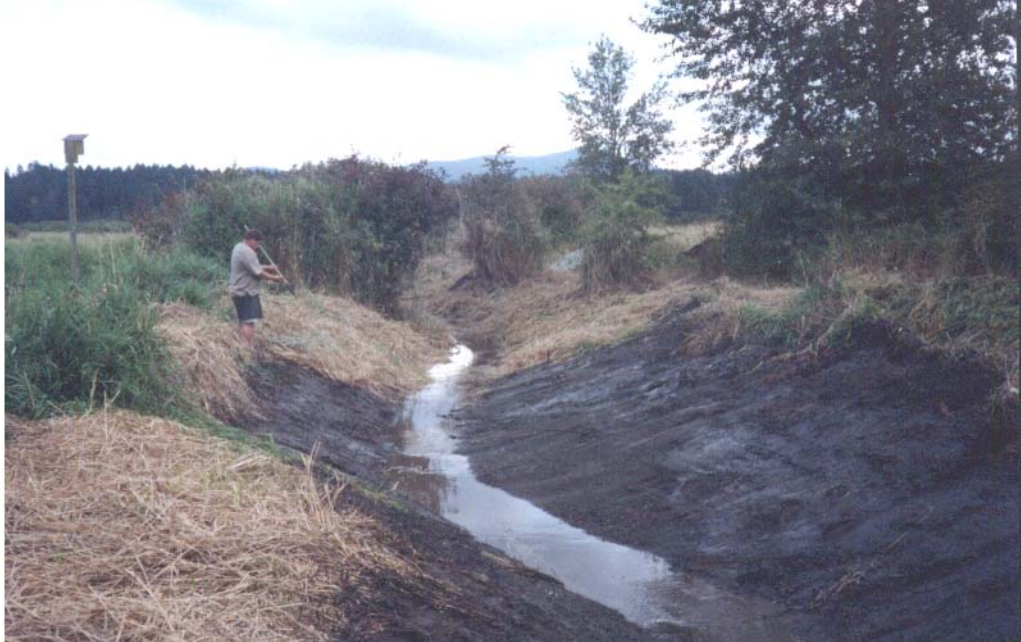
Photo 5: Following excavation, RCG cuttings were cast over the raw banks to retard its growth

Special effort was made to plug breakout channels on the north bank. Reed Canary Grass sods were uprooted, turned over and punched into the spill points. Because the channel banks were so raw, Reed Canary Grass cuttings were placed over them to provide protection from raindrop impact and rill erosion, shade out initial reed Canary Grass sprouting (new shoots appeared on bare spots just three days after excavation) and provide a somewhat firmer footing for people planting riparian vegetation.

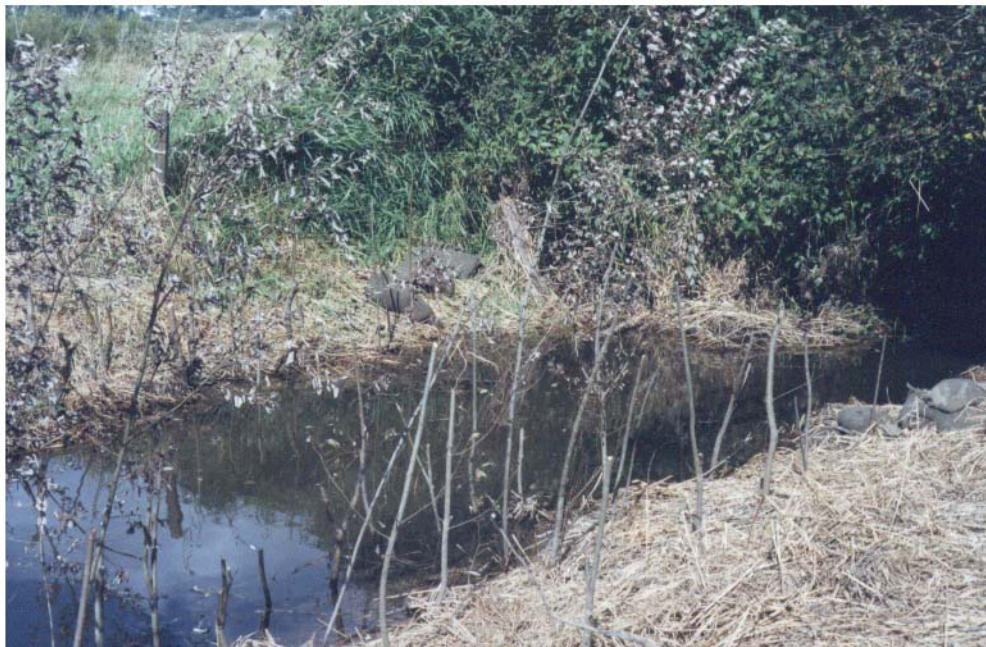
Photo 6: Willow, cottonwood and red osier cuttings were planted along with some whole pole saplings to discourage aerial predators.

Riparian planting began on Aug. 31 and continues. 92 m of streambank was planted with willow cuttings (largely Scouler's with some Pacific) and some Red Osier and Black Cottonwood from a source within Somenos Marsh. In addition to the willow cuttings, the lower 92 m was also planted with cut off trees that were angled over the streambank to provide protection from aerial predators and provide some shade (stream temperature during the project only ranged between 14 and 17° so shade was not particularly important from a temperature viewpoint).
